## **HUMAN FACTORS EVALUATION OF THE SINCGARS ICOM RADIO**

Richard L. Palmer

U.S. Army Research Institute  
Fort Hood Field Unit

April 1987

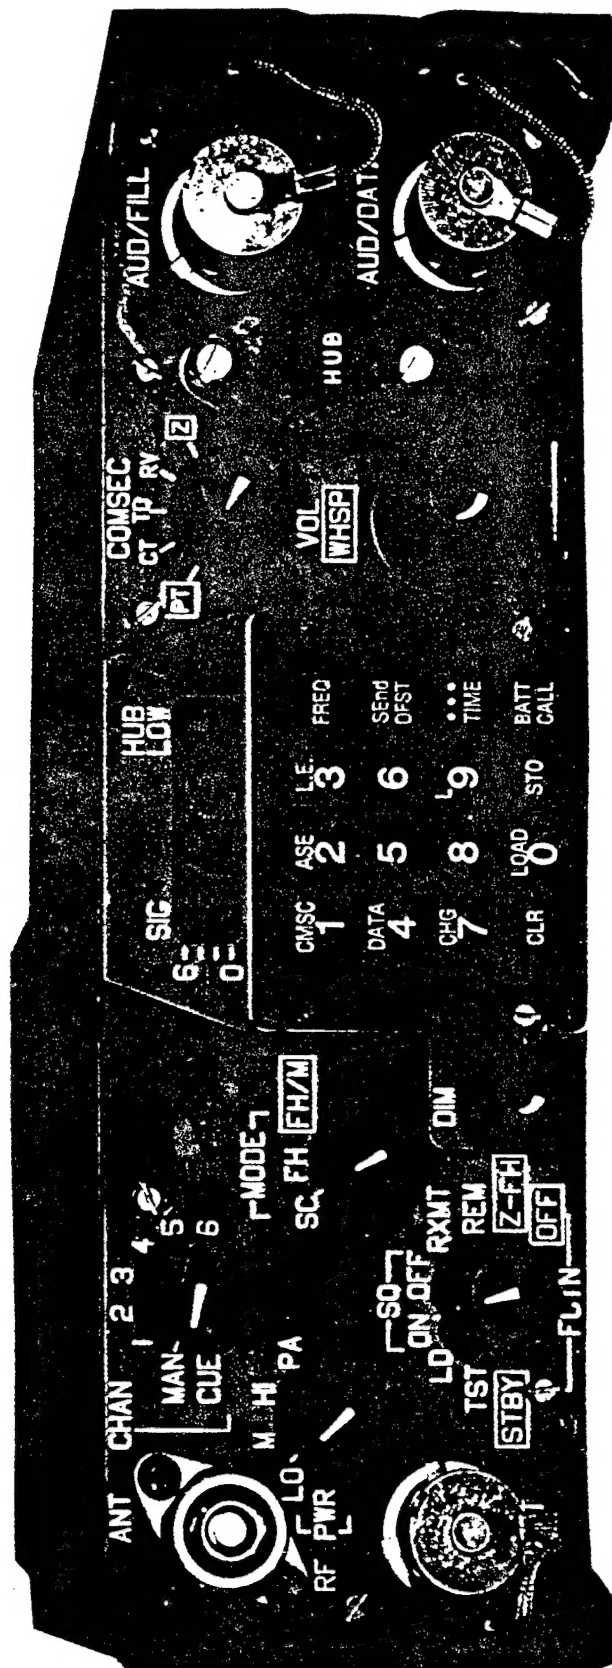
Figure 1. Front panel of the SINGGARS first-generation Integrated COMSEC (ICOM) radio.

The findings are presented as observations organized into six sections: Operating Controls, Display, Labels, Connectors, Operational Procedures, and Miscellaneous. Each observation is accompanied by an impact assessment, comments, and suggested solutions. Reference may be made to Figure 1 (at the end of this document), which depicts the front panel of the SINCGARS ICOM radio.
